**Flood Control Project Maintenance
Levee Inspections**

Fall 2016 Levee Maintenance Deficiency Summary Report

Sacramento River Basin

Sutter Maintenance Yard Wadsworth Canal

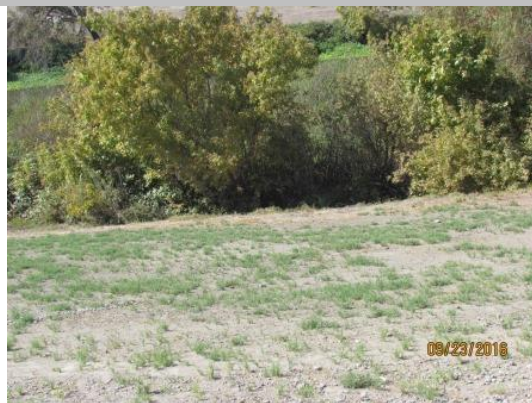
Photo 1 of 1 : FA_2016_ST0010_42_20_20161003_00026.jpg

View of the erosion along the waterside toe.

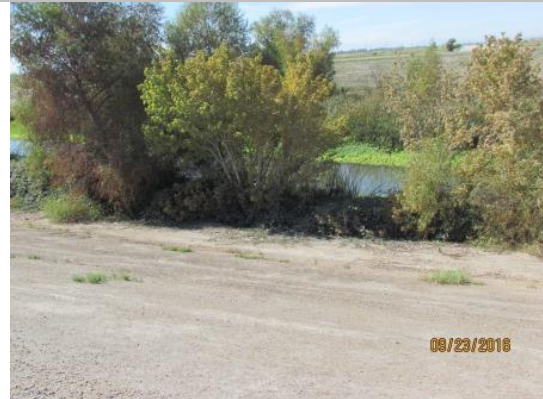
Photo 1 of 1 : FA_2016_ST0010_42_19_20161003_00025.jpg

View of the erosion along the waterside toe.

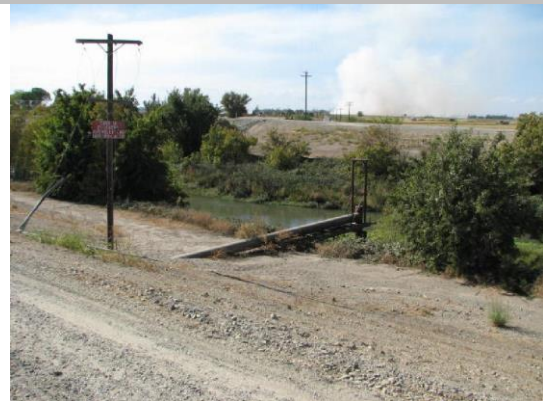
Photo 1 of 2 : UCIP_FA_2016_50356_64702.jpg

Comment Code					
Inspector Comment					
FS_ID:50356 DS_ID:17059 EP_NO: 1605 Repair Type: Non-Urgent Crossing Status: Found UCIP Comments: 10/12/2016 Abandoned crossing.(DWR Sutter Yard - afreitag)4/16/2016 Abandoned crossing. Ws pipe end is open and should be capped.5/12/2015 Abandoned crossing. Needs to be properly abandoned.11/18/2014 Same as last inspection.5/13/2014 Same as last inspection.10/29/2013 Same as last inspection.5/16/2013 Same as last inspection.10/9/2012 No pump on Pier and power lines cut. Apparently abandoned-should be abandoned properly. FIELD_STRUCT_DESC: *ABANDONED* 18-inch steel irrigation pipe (permit records indicate 16-inch pipe) through the levee, 3.7 feet below the crown. Siphon breaker on the wterside (WS) slope. Pump on channel bank on steel structure. (16-inch pipe authorized under Permit No. 1605, 1959 - Schnabel, aerial 12 KV power line extension for pump authorized under Permit No. 1631, 1959 - Pacific Gas and Electric Company [PG&E]) [Additional Reference(s): DWR Levee Log, 2005]. FS Date: 10/12/2016 12:22:19 PM

Power pole with cut powerlines, pump missing from steel pier.

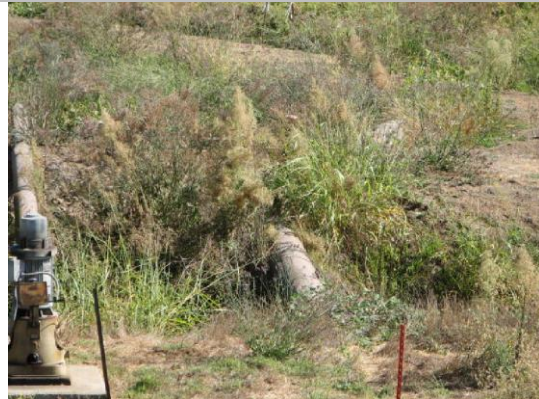
Photo 2 of 2 : UCIP_FA_2016_50356_64701.jpg

Comment Code					
Inspector Comment					
FS_ID:50356 DS_ID:17059 EP_NO: 1605 Repair Type: Non-Urgent Crossing Status: Found UCIP Comments: 10/12/2016 Abandoned crossing.(DWR Sutter Yard - afreitag)4/16/2016 Abandoned crossing. Ws pipe end is open and should be capped.5/12/2015 Abandoned crossing. Needs to be properly abandoned.11/18/2014 Same as last inspection.5/13/2014 Same as last inspection.10/29/2013 Same as last inspection.5/16/2013 Same as last inspection.10/9/2012 No pump on Pier and power lines cut. Apparently abandoned-should be abandoned properly. FIELD_STRUCT_DESC: *ABANDONED* 18-inch steel irrigation pipe (permit records indicate 16-inch pipe) through the levee, 3.7 feet below the crown. Siphon breaker on the wterside (WS) slope. Pump on channel bank on steel structure. (16-inch pipe authorized under Permit No. 1605, 1959 - Schnabel, aerial 12 KV power line extension for pump authorized under Permit No. 1631, 1959 - Pacific Gas and Electric Company [PG&E]) [Additional Reference(s): DWR Levee Log, 2005]. FS Date: 10/12/2016 12:22:19 PM

Pipe on LS toe.

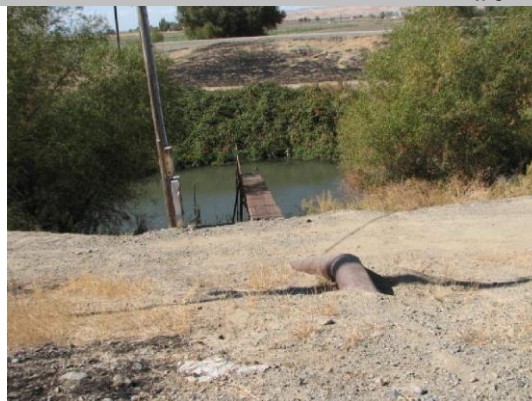
Photo 1 of 2 : UCIP_FA_2016_50361_64711.jpg

FS_ID:50361
DS_ID:17063
EP_NO: N/A
Repair Type: Non-Urgent
Crossing Status: Found
UCIP Comments: 10/12/2016 Abandoned crossing.(DWR Sutter Yard - afreitag)4/19/2016 Abandoned crossing. No noticeable issues to report.5/12/2015 Abandoned crossing. Cap was made and installed on WS open end of pipe.11/18/2014 Same as last inspection.5/13/2014 Cap was made and bolted on to WS open end of pipe.10/29/2013 Same as last inspection.5/16/2013 Same as last inspection. Steve Beckley is looking into finding pipe owner to properly abandon pipe.10/9/2012 Pipe abandoned. Pipe open and not plugged. Pipe should be removed or abandoned properly. Extensive animal burrowing occurring along pipe alignment.
FIELD_STRUCT_DESC: *ABANDONED* 14-inch steel irrigation pipe (permit records reference 24-inch corrugated metal in 1939 and existing 18-inch pipe in 1932 through levee, USACE O&M references 15-inch pipe 1953) through the levee, 5.7 feet below the crown. Siphon breaker is located on the landside (LS). Vertical pump located on the waterside (WS). Meter pole located on the WS berm. (permit authorized existing 18-inch pipe and new install of pump under Permit No. 572, 1932 - Joaquin). [Additional Reference(s): DWR Levee Log, 2005. USACE Sacramento O&M Manual 135, May 1953, (Station 98+02)].

Pump missing from steel pier on WS toe.

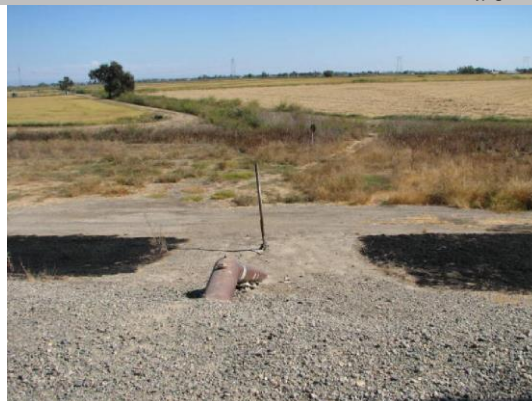
Photo 2 of 2 : UCIP_FA_2016_50361_64710.jpg

Pipe with siphon breaker plugged on LS shoulder.

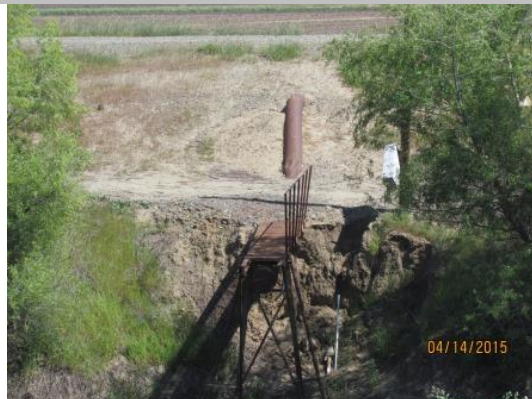
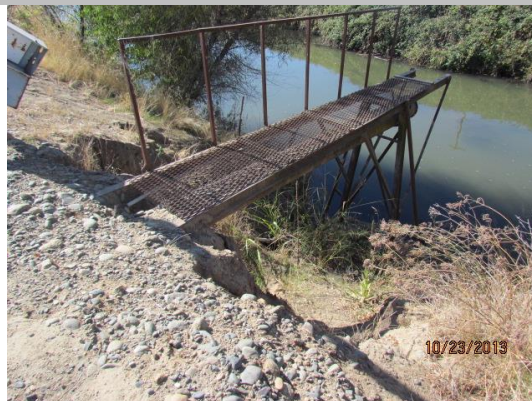
LM Start	1.85	Rating **	U	Issue No.	107
LM End	1.85	Issue Type +	Ma	Location *	WS
Category	Earthen Levee			GPS Latitude/Longitude	
				Start	End
Item	Erosion / Bank Caving			39.135110 °	39.135110 °
				-121.748230 °	-121.748230 °
DWR ID	DWR_ST0010_01_f_2013_107				
Comment Code					
E2 : Schedule repair of erosion site prior to the next inspection.					
Inspector Comment					
Repair the erosion under the abandoned pump.

View of the erosion along both sides of the abandoned pump.

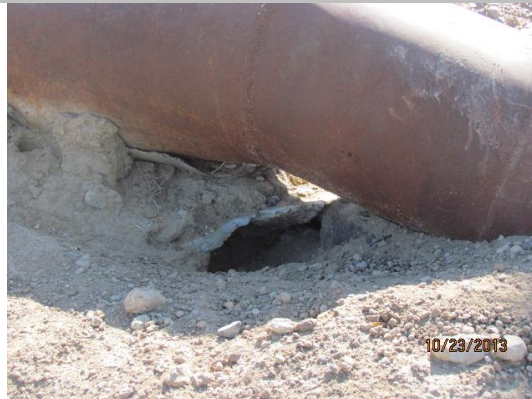
Photo 1 of 1 : FA_2016_ST0010_42_106_20160823_00011.jpg

LM Start	1.85	Rating **	M	Issue No.	106
LM End	1.85	Issue Type +	Ma	Location *	WS
Category	Earthen Levee			GPS Latitude/Longitude	
				Start	End
Item	Animal Control			39.135110 °	39.135110 °
				-121.748229 °	-121.748229 °
DWR ID	DWR_ST0010_01_f_2013_106				
Comment Code					
A3 : No rodents visible, but rodent burrows visible; need to backfill and compact or grout burrows.					
Inspector Comment

View of the rodent holes under the irrigation pipe.

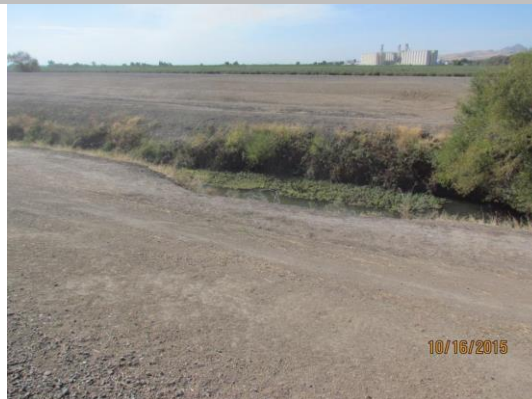
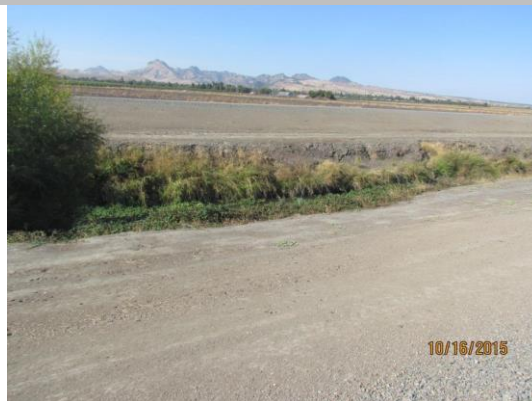
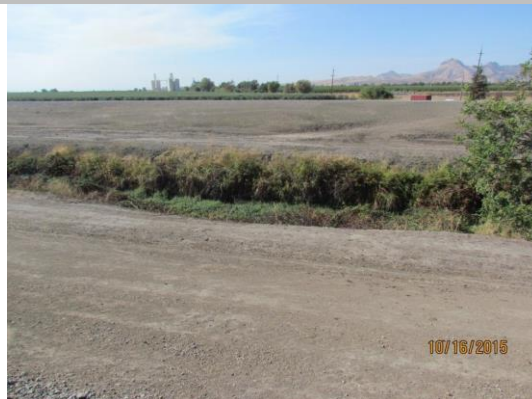
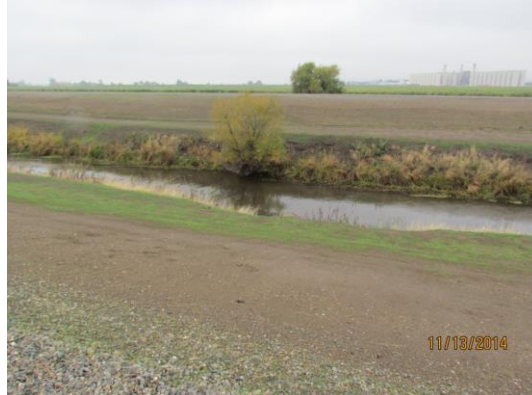
View of the erosion along the waterside toe.

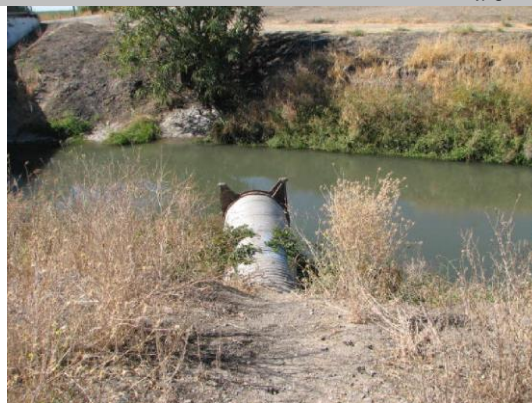
Photo 1 of 2 : UCIP_FA_2016_50363_64718.jpg

Comment Code					
Inspector Comment					
FS_ID:50363 DS_ID:17065 EP_NO: 7209 Repair Type: Non-Urgent Crossing Status: Found UCIP Comments: 10/12/2016 LS inlet is still deformed and being overgrown by vegetation.(DWR Sutter Yard - afreitag)4/19/2016 Crossing appears to be in good condition.5/12/2015 LS inlet still deformed a little but does not affect the crossing function.11/18/2014 Same as last inspection.5/13/2014 Same as last inspection.10/29/2013 Same as last inspection.5/16/2013 Pipe intake on LS appears to be bent and damaged but that does not appear to be affecting water flow or channel bank. FIELD_STRUCT_DESC: 36-inch corrugated metal drainage pipe (permit records indicate 30-inch USACE O&M pipe replaced with new 30-inch pipe) through the levee, 9 feet below the crown. Flap gate located on the waterside (WS) end. (original O&M manual crossing was replaced under Permit No. 7209, 1970 - Department of Water Resources) [Additional Reference(s): DWR Levee Log, 2005. USACE Sacramento O&M Manual 135, May 1953, (Station 160+25)]. FS Date: 10/12/2016 1:01:13 PM

36-inch pipe with flapgate on WS slope.

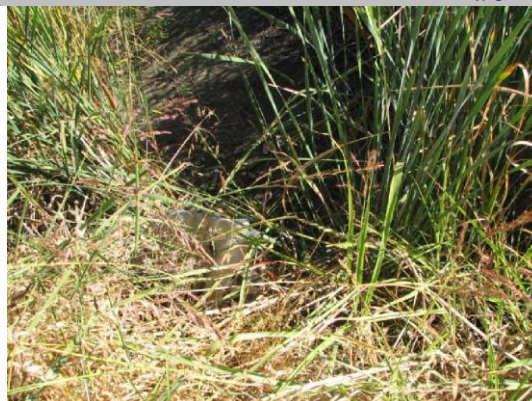
Photo 2 of 2 : UCIP_FA_2016_50363_64717.jpg

Item	DWR UCIP Field Study			39.149549 °	39.149549 °	
				-121.736408 °	-121.736408 °	
DWR ID						
Comment Code						
Inspector Comment						
FS_ID:50363 DS_ID:17065 EP_NO: 7209 Repair Type: Non-Urgent Crossing Status: Found UCIP Comments: 10/12/2016 LS inlet is still deformed and being overgrown by vegetation.(DWR Sutter Yard - afreitag)4/19/2016 Crossing appears to be in good condition.5/12/2015 LS inlet still deformed a little but does not affect the crossing function.11/18/2014 Same as last inspection.5/13/2014 Same as last inspection.10/29/2013 Same as last inspection.5/16/2013 Pipe intake on LS appears to be bent and damaged but that does not appear to be affecting water flow or channel bank. FIELD_STRUCT_DESC: 36-inch corrugated metal drainage pipe (permit records indicate 30-inch USACE O&M pipe replaced with new 30-inch pipe) through the levee, 9 feet below the crown. Flap gate located on the waterside (WS) end. (original O&M manual crossing was replaced under Permit No. 7209, 1970 - Department of Water Resources) [Additional Reference(s): DWR Levee Log, 2005. USACE Sacramento O&M Manual 135, May 1953, (Station 160+25)]. FS Date: 10/12/2016 1:01:13 PM

Inlet in weeds on LS toe.

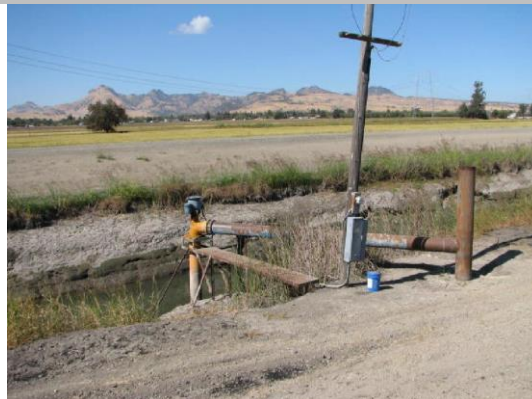
Photo 1 of 2 : UCIP_FA_2016_50365_64720.jpg

FS_ID:50365
DS_ID:17066
EP_NO: N/A
Repair Type: Non-Urgent
Crossing Status: Found
UCIP Comments: 10/12/2016 Crossing appears to be in good condition. 4/19/2016 Crossing has not changed since the last inspection. LS headwall is silted in and not being used. LS pipe end discharges into the rice field. 5/12/2015 Concrete headwall on LS is completely silted in. LS pipe end is located near the edge of rice field. No issues seen on WS. 11/18/2014 Same as last inspection. 5/13/2014 Same as last inspection. 10/29/2013 Concrete headwall is silted in and appears to be abandoned. Discharge end of pipe is approx. 100ft. from LS toe on the edge of the rice field. 5/16/2013 Same as last inspection.
FIELD_STRUCT_DESC: 24-inch steel irrigation pipe (USACE O&M refers to 24-inch corrugated metal pipe) through the levee, 11 feet below the crown. Slide gate in 4-foot by 6-foot concrete distribution box located at the waterside (WS) toe. (not found in 2012) Vertical pump mounted on a steel structure in channel. Service pole on the berm with 18-inch standpipe located on the WS toe. Concrete "U" shaped headwall located on the landside (LS) toe. [Additional Reference(s): DWR Levee Log, 2005. USACE Sacramento O&M Manual 135, May 1953, (Station 184+87)].

Pump, Pipe, walkway, power pole, and standpipe on WS toe.

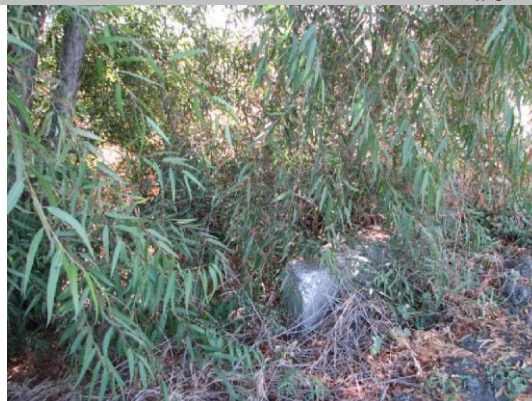
Photo 2 of 2 : UCIP_FA_2016_50365_64719.jpg

Concrete U shaped headwall on LS toe under tree.

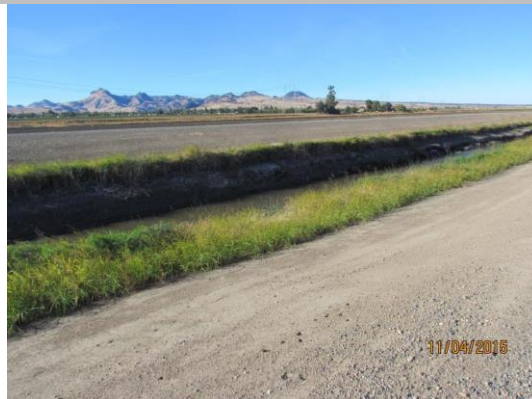
Photo 1 of 1 : FA_2016_ST0010_42_3_20160823_00001.jpg

View of the erosion along the waterside toe.

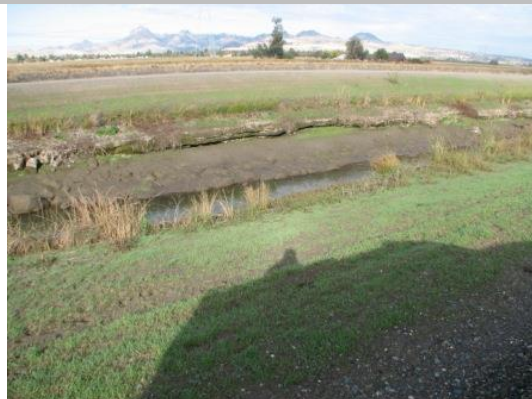
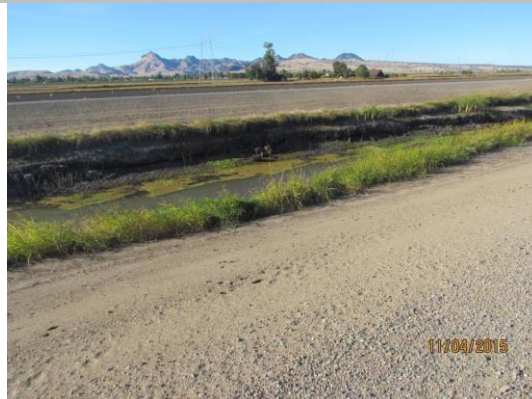
LM Start	3.65	Rating **	M	Issue No.	4
LM End	3.65	Issue Type +	Ma	Location *	WS
Category	Earthen Levee			GPS Latitude/Longitude	
				Start	End
Item	Erosion / Bank Caving			39.157861 °	39.157861 °
				-121.732238 °	-121.732238 °
DWR ID	DWR_ST0010_01_s_2012_4				
Comment Code					
E1 : Note and monitor erosion site.					
Inspector Comment					
Monitor the erosion along the waterside toe.

View of the erosion along the waterside toe of the levee.

View of the erosion along the waterside toe.

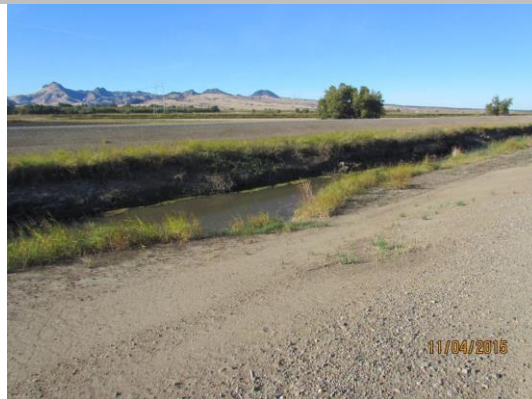
Photo 1 of 1 : FA_2016_ST0010_42_17_20160823_00010.jpg

View of the erosion along the waterside toe.

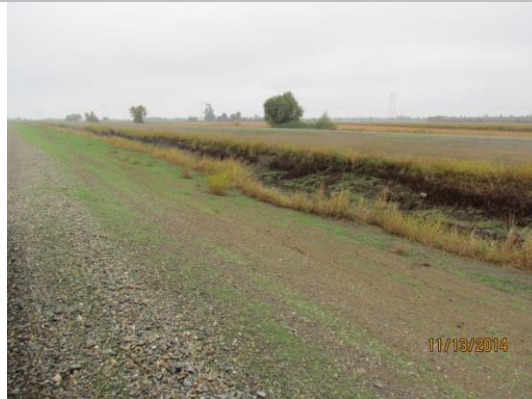
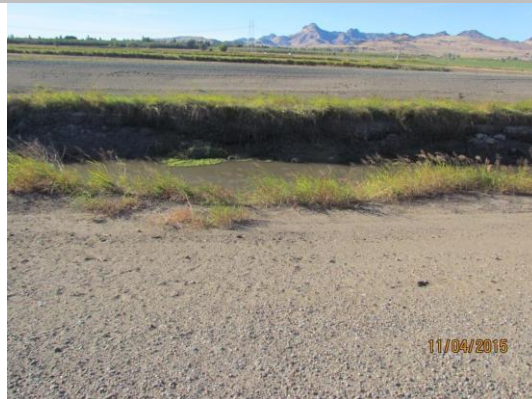
LM Start	4.23	Rating **	M	Issue No.	5
LM End	4.23	Issue Type +	Ma	Location *	WS
Category	Earthen Levee			GPS Latitude/Longitude	
				Start	End
Item	Erosion / Bank Caving			39.165845 °	39.165845 °
				-121.728877 °	-121.728877 °
DWR ID	DWR_ST0010_01_s_2012_5				
Comment Code					
E1 : Note and monitor erosion site.					
Inspector Comment					
Monitor the erosion along the waterside toe.

View of the erosion along the waterside toe.

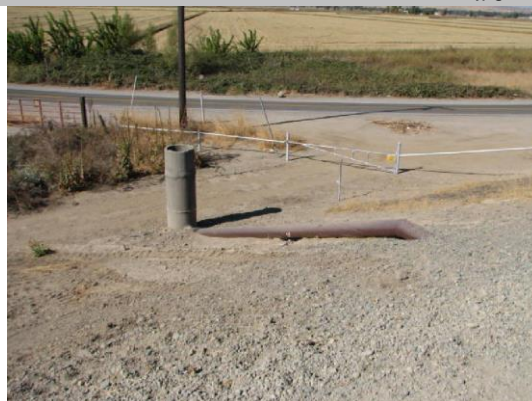
Photo 1 of 2 : UCIP_FA_2016_50369_64728.jpg

FS_ID:50369
DS_ID:17069
EP_NO: N/A
Repair Type: Non-Urgent
Crossing Status: Found
UCIP Comments: 10/12/2016 Abandoned crossing.(DWR Sutter Yard - afreitag)4/19/2016 Abandoned crossing. Rodent activity still present on WS slope.5/12/2015 Abandoned crossing. Signs of rodent activity on both sides of levee.11/18/2014 Same as last inspection.5/13/2014 Same as last inspection.10/29/2013 Same as last inspection.5/16/2013 Same as last inspection.10/9/2012 Pipe appears improperly abandoned. No motor present, electrical equipment is stripped. Heavy rodent activity along pipe WS and LS. Pipe needs to be removed or properly abandoned.
FIELD_STRUCT_DESC: *ABANDONED* 10-inch steel irrigation pipe through the levee, 4.8 feet below the crown. Pump mounted on concrete pad near canal bank located on the waterside (WS). Service pole located on the berm. 36-inch concrete standpipe located on the landside (LS) toe. (Permit No. 945, 1944 - Becker). [Additional Reference(s): DWR Levee Log, 2005. USACE Sacramento O&M Manual 135, May 1953, (Station 61+10)].

Pipe and Standpipe on LS toe.

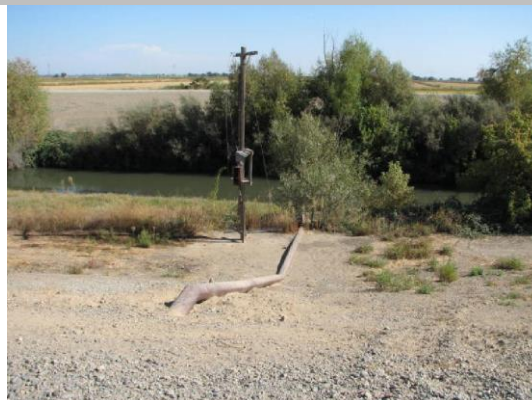
Photo 2 of 2 : UCIP_FA_2016_50369_64727.jpg

Pipe and pump facilities on WS slope.

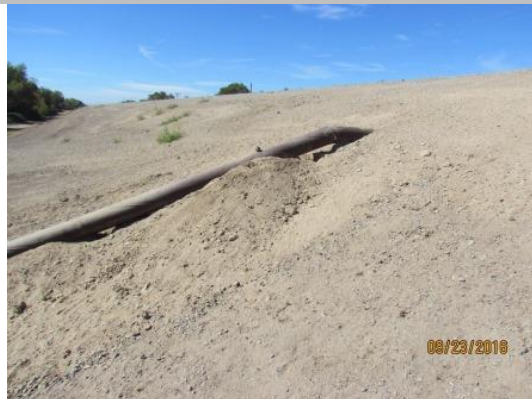
Photo 1 of 1 : FA_2016_ST0010_43_19_20161003_00031.jpg

View of the rodent holes along the landside slope.

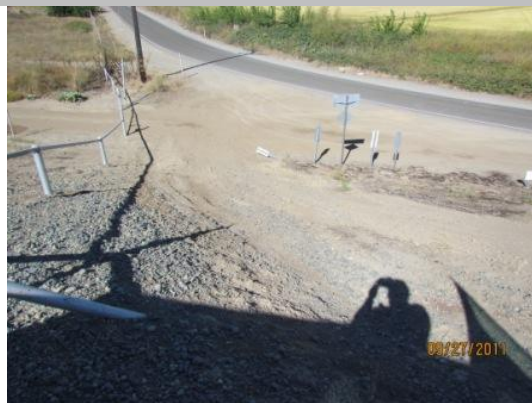
Photo 1 of 1 : FA_2016_ST0010_43_3_20160823_00001.jpg

LM Start	1.17	Rating **	M	Issue No.	3
LM End	1.17	Issue Type +	Ma	Location *	LS
Category	Earthen Levee			GPS Latitude/Longitude	
				Start	End
Item	Slope Stability			39.127648 °	39.127648 °
				-121.756345 °	-121.756345 °
DWR ID	DWR_ST0010_02_s_2012_3				
Comment Code					
S3 : Repair the levee slope damaged by vehicle traffic and prevent access where possible.					
Inspector Comment

View of vehicle erosion along L/S slope.

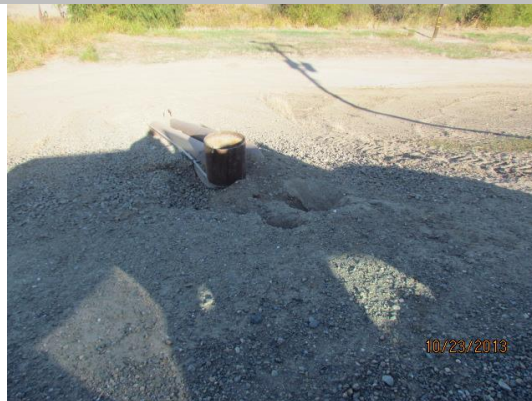
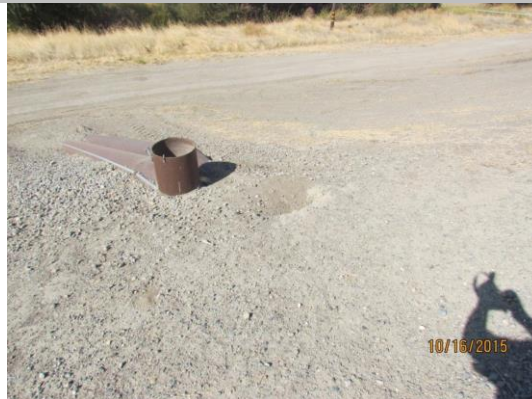
LM Start	1.76	Rating **	M	Issue No.	11
LM End	1.76	Issue Type +	Ma	Location *	LS
Category	Earthen Levee			GPS Latitude/Longitude	
				Start	End
Item	Animal Control			39.134490 °	39.134490 °
				-121.749716 °	-121.749716 °
DWR ID	DWR_ST0010_02_f_2012_11				
Comment Code					
A3 : No rodents visible, but rodent burrows visible; need to backfill and compact or grout burrows.					
Inspector Comment					
Repair the rodent hole.

View of the rodent holes above the irrigation pipe.

View of the rodent hole above the irrigation pipe.

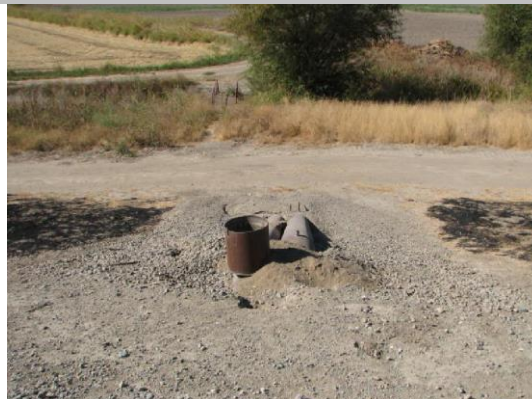
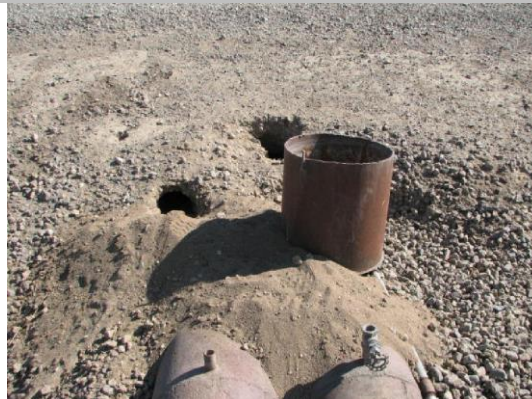
FS_ID:50374
DS_ID:17074
EP_NO: 1096
Repair Type: Non-Urgent
Crossing Status: Found
UCIP Comments: 10/12/2016 Crossing appears to be in good condition. Minor rodent activity nearby.(DWR Sutter Yard - afreitag)4/19/2016 No signs of pipe leaks. Still some minor rodent activity under the pipe on LS slope.5/12/2015 Rodent activity near pipe on LS.11/18/2014 Levee inspection is aware of problem and repairs seem to have been made. Slope has also been rocked to prevent erosion.5/13/2014 Air vent on LS shoulder leaks and is causing minor erosion to the LS slope.10/29/2013 Same as last inspection.5/16/2013 Same as last inspection.10/9/2012 Heavy rodent activity on LS slope along pipe alignment.
FIELD_STRUCT_DESC: 16-inch steel irrigation pipe (USACE O&M refers to 15-inch pipe) through the levee, 4.4 feet below the crown. Pump mounted on a steel structure located on the waterside (WS) bank. Siphon breaker located on the WS slope. 48-inch concrete standpipe located on the landside (LS) berm (not found 2012). (16-inch pipe authorized under Permit No. 1096, 1946 - Ziegenmeyer, owner name change for structure authorized under Permit No. 1479, 1950 - Brown). [Additional Reference(s): DWR Levee Log, 2005. USACE Sacramento O&M Manual 135, May 1953, (Station 93+55)].

Pipe on LS with rodent activity shown.

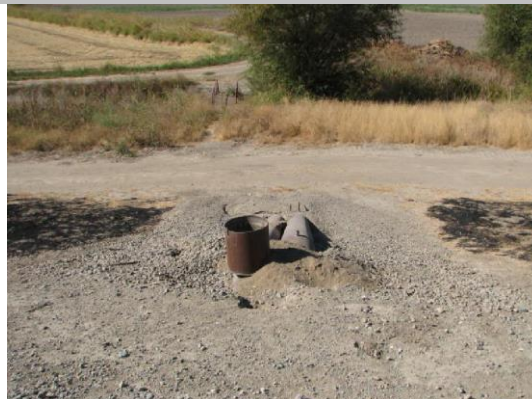
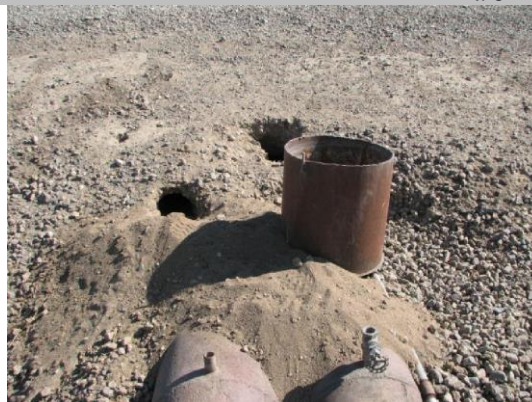
Comment Code					
Inspector Comment					
FS_ID:50375 DS_ID:17082 EP_NO: N/A Repair Type: Non-Urgent Crossing Status: Found UCIP Comments: 10/12/2016 Abandoned crossing. Minor rodent activity near by.(DWR Sutter Yard - afreitag)4/19/2016 Crossing appears abandoned. Minor rodent activity under pipe on LS slope.5/12/2015 Abandoned crossing that needs to be properly abandoned. Rodent activity near LS pipe.11/18/2014 Same as last inspection.5/13/2014 Same as last inspection.10/29/2013 Same as last inspection.5/16/2013 Same as last inspection.10/9/2012 Heavy rodent activity along LS alignment of pipe. No pump on structure and it appears to be abandoned. Should be abandoned properly. FIELD_STRUCT_DESC: *ABANDONED* 16-inch steel irrigation pipe through the levee, 4.4 feet below the crown. Pump mounted on a timber structure located on the waterside (WS). Siphon breaker located on the landside (LS) slope. 48-inch concrete standpipe located on the LS berm (not found 2012). (Permit No. 1104, 1946 - Muns) [Additional Reference(s): DWR Levee Log, 2005]. FS Date: 10/13/2016 7:41:35 AM

Pipe on LS showing rodent activity.

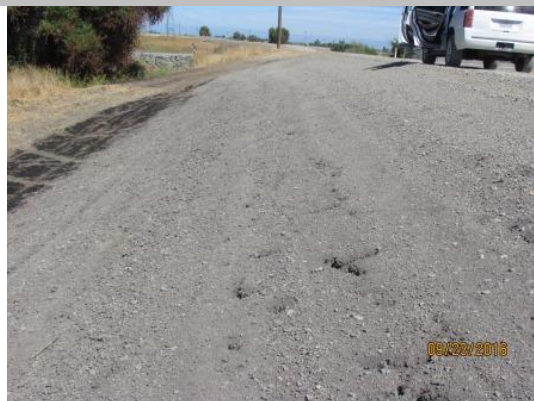
Photo 1 of 1 : FA_2016_ST0010_43_22_20161003_00034.jpg

LM Start	2.95	Rating **	M	Issue No.	22
LM End	2.95	Issue Type +	Ob	Location *	LS
Category	Earthen Levee			GPS Latitude/Longitude	
				Start	End
Item	Cracking			39.148938 °	39.148938 °
				-121.737620 °	-121.737620 °
DWR ID	DWR_ST0010_02_f_2016_22				
Comment Code					
CR1 : Monitor and have inspected by geotechnical engineer.					
Inspector Comment					
Longitudinal cracks caused by fat clay.

View of the longitudinal cracks along the landside slope.

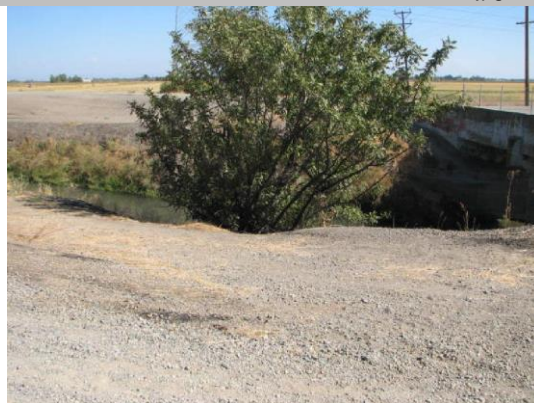
Photo 1 of 2 : UCIP_FA_2016_50378_64744.jpg

Comment Code					
Inspector Comment					
FS_ID:50378 DS_ID:17077 EP_NO: 7209 Repair Type: Non-Urgent Crossing Status: Found UCIP Comments: 10/12/2016 Tree at the WS pipe end is still an issue and needs to be cut away. LS inlet is also being overgrown with vegetation.(DWR Sutter Yard - afreitag)4/19/2016 Tree at WS pipe end needs to be trimmed back and/or removed. 5/12/2015 Tree growing near WS pipe end is getting too big and will affect the crossing. It needs to be cut back or removed.11/18/2014 Same as last inspection.5/13/2014 Same as last inspection.10/29/2013 Same as last inspection.5/16/2013 Same as last inspection. FIELD_STRUCT_DESC: 36-inch corrugated metal drainage pipe (permit records indicate 30-inch pipe O&M pipe replaced with new 30-inch pipe) through the levee, 14 feet below the crown. Flap gate located on the waterside (WS) end. (original O&M manual crossing was replaced under Permit No. 7209, 1970 - Department of Water Resources) [Additional Reference(s): DWR Levee Log, 2005. USACE Sacramento O&M Manual 135, May 1953, (Station 158+35)]. FS Date: 10/13/2016 7:48:59 AM

Bush camouflaging outlet of pipe on WS slope.

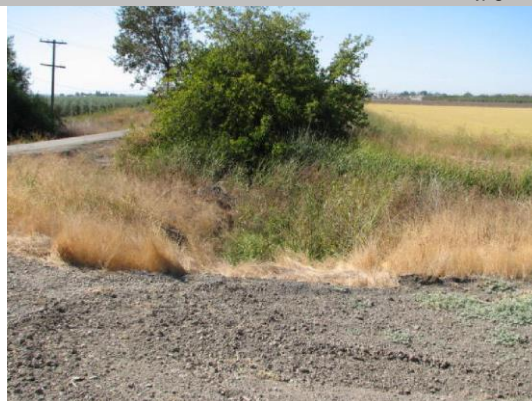
Photo 2 of 2 : UCIP_FA_2016_50378_64743.jpg

Comment Code						
Inspector Comment						
FS_ID:50378 DS_ID:17077 EP_NO: 7209 Repair Type: Non-Urgent Crossing Status: Found UCIP Comments: 10/12/2016 Tree at the WS pipe end is still an issue and needs to be cut away. LS inlet is also being overgrown with vegetation.(DWR Sutter Yard - afreitag)4/19/2016 Tree at WS pipe end needs to be trimmed back and/or removed. 5/12/2015 Tree growing near WS pipe end is getting too big and will affect the crossing. It needs to be cut back or removed.11/18/2014 Same as last inspection.5/13/2014 Same as last inspection.10/29/2013 Same as last inspection.5/16/2013 Same as last inspection. FIELD_STRUCT_DESC: 36-inch corrugated metal drainage pipe (permit records indicate 30-inch pipe O&M pipe replaced with new 30-inch pipe) through the levee, 14 feet below the crown. Flap gate located on the waterside (WS) end. (original O&M manual crossing was replaced under Permit No. 7209, 1970 - Department of Water Resources) [Additional Reference(s): DWR Levee Log, 2005. USACE Sacramento O&M Manual 135, May 1953, (Station 158+35)]. FS Date: 10/13/2016 7:48:59 AM

Heavy vegetation at LS inlet at channel.

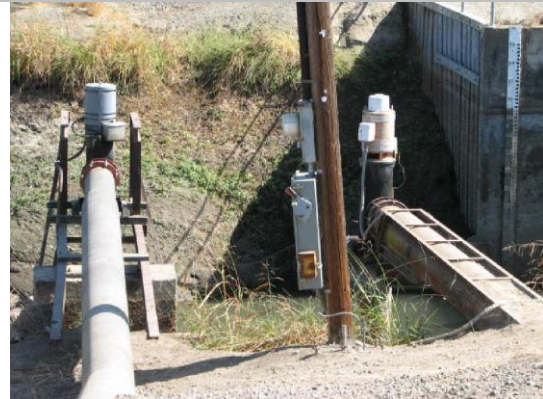
Photo 1 of 2 : UCIP_FA_2016_50381_64761.jpg

Comment Code					
Inspector Comment					
FS_ID:50381 DS_ID:17078 EP_NO: 10473 Repair Type: Non-Urgent Crossing Status: Found UCIP Comments: 10/12/2016 WS appears to be in good condition. LS is still very rusted where it extends over the LS ditch.(DWR Sutter Yard - afreitag)4/19/2016 No changes have been made to this crossing. LS pipe outlet is still very rusted. 5/12/2015 Pipe is very rusty at Outlet in LS channel. No noticeable issues with WS.11/18/2014 Same as last inspection.5/13/2014 Same as last inspection.10/29/2013 Same as last inspection.5/16/2013 Same as last inspection.10/9/2012 Pipe shows signs of heavy rust at outlet in channel. Good candidate for video inspection. FIELD_STRUCT_DESC: 16-inch asphalt coated steel irrigation pipe through the levee, 2.7 feet below the crown. 16-inch pipe was measured during the UCIP field inspection, record sources at this location reference the following pipe diameter size: USACE O&M manual references a 24-inch pipe, levee logs reference a 22-inch pipe, and permit records reference a 22-inch pipe. Unable to determine if original 22-inch pipe is still present through the levee. Vertical pump in the channel with a service pole on the waterside (WS) berm. Pipe discharges into 36-inch concrete standpipe located on the landside (LS) toe of the levee. (retain existing 22-inch pipe through levee and remove existing 12-inch pipe and replaced with 12-inch pipe under Permit No. 5622, 1967 - Webb, remove 12-inch pipe and replace with 12-inch pipe under Permit No. 10473, 1976 - Brown, install 16-inch pipe from canal to levee slope and modify existing 22-inch pipe under Permit No. 10473-A, 1976 - Brown). [Additional Reference(s): DWR Levee Log, 2005. USACE Sacramento O&M Manual 135, May 1953, (Station 174+63)]. FS Date: 10/13/2016 8:00:20 AM

Pump on steel pier at WS toe.

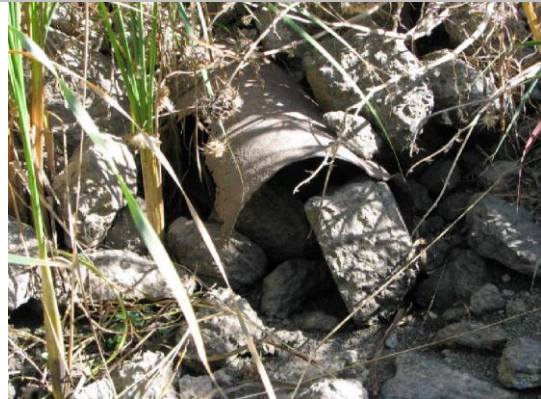
Photo 2 of 2 : UCIP_FA_2016_50381_64760.jpg

Comment Code						
Inspector Comment						
FS_ID:50381 DS_ID:17078 EP_NO: 10473 Repair Type: Non-Urgent Crossing Status: Found UCIP Comments: 10/12/2016 WS appears to be in good condition. LS is still very rusted where it extends over the LS ditch.(DWR Sutter Yard - afreitag)4/19/2016 No changes have been made to this crossing. LS pipe outlet is still very rusted. 5/12/2015 Pipe is very rusty at Outlet in LS channel. No noticeable issues with WS.11/18/2014 Same as last inspection.5/13/2014 Same as last inspection.10/29/2013 Same as last inspection.5/16/2013 Same as last inspection.10/9/2012 Pipe shows signs of heavy rust at outlet in channel. Good candidate for video inspection. FIELD_STRUCT_DESC: 16-inch asphalt coated steel irrigation pipe through the levee, 2.7 feet below the crown. 16-inch pipe was measured during the UCIP field inspection, record sources at this location reference the following pipe diameter size: USACE O&M manual references a 24-inch pipe, levee logs reference a 22-inch pipe, and permit records reference a 22-inch pipe. Unable to determine if original 22-inch pipe is still present through the levee. Vertical pump in the channel with a service pole on the waterside (WS) berm. Pipe discharges into 36-inch concrete standpipe located on the landside (LS) toe of the levee. (retain existing 22-inch pipe through levee and remove existing 12-inch pipe and replaced with 12-inch pipe under Permit No. 5622, 1967 - Webb, remove 12-inch pipe and replace with 12-inch pipe under Permit No. 10473, 1976 - Brown, install 16-inch pipe from canal to levee slope and modify existing 22-inch pipe under Permit No. 10473-A, 1976 - Brown). [Additional Reference(s): DWR Levee Log, 2005. USACE Sacramento O&M Manual 135, May 1953, (Station 174+63)]. FS Date: 10/13/2016 8:00:20 AM

Rusted outlet at LS channel. Unclear if this is same pipe as one under investigation.

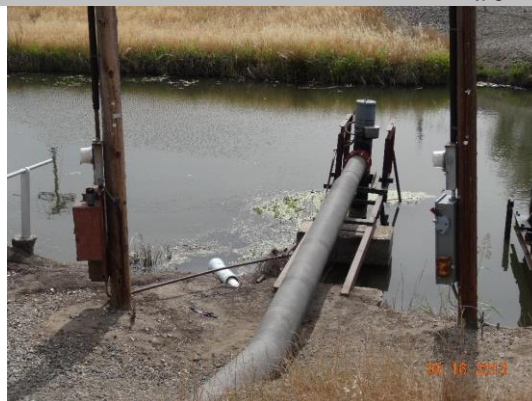
Photo 1 of 2 : UCIP_FA_2016_50382_64764.jpg

Pump station in channel on WS

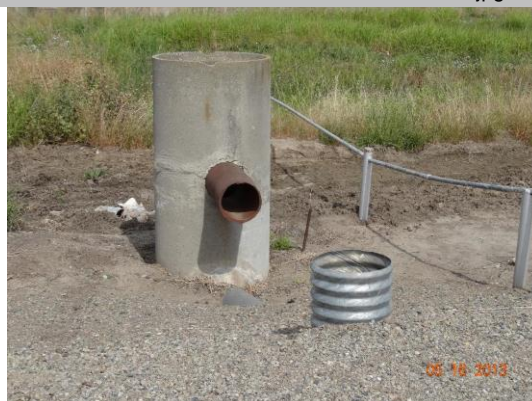
Photo 2 of 2 : UCIP_FA_2016_50382_64763.jpg

36in. concrete standpipe and 12in. cm riser on LS.

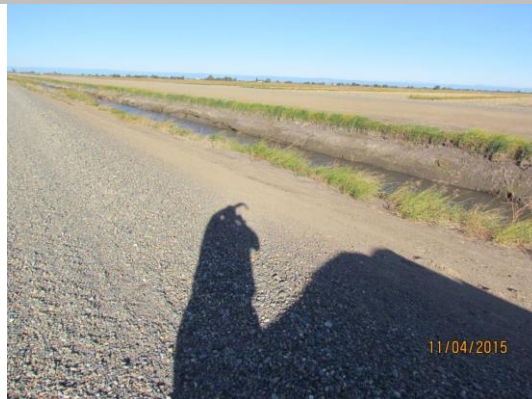
Photo 2 of 2 : FA_2016_ST0010_43_5_20160823_00005.jpg

View of erosion at the waterside toe

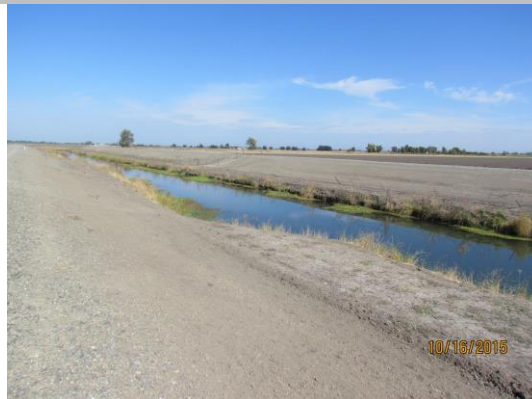
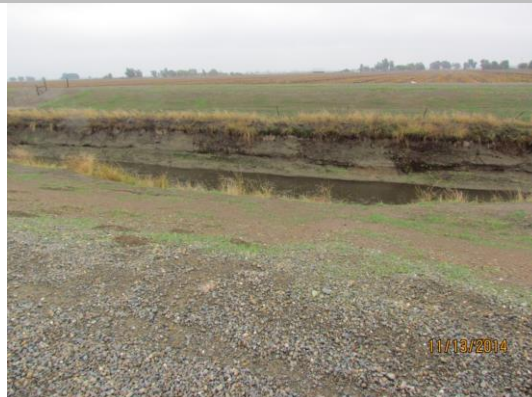
View of the erosion along the waterside toe.

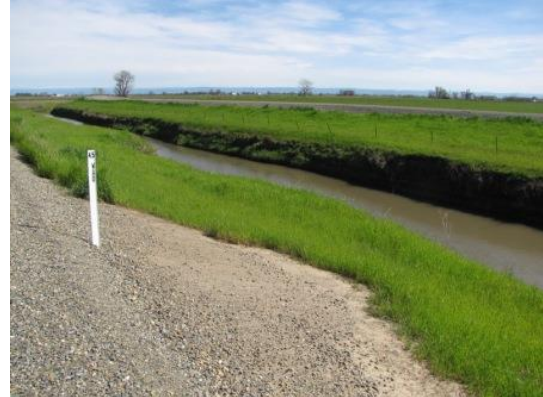
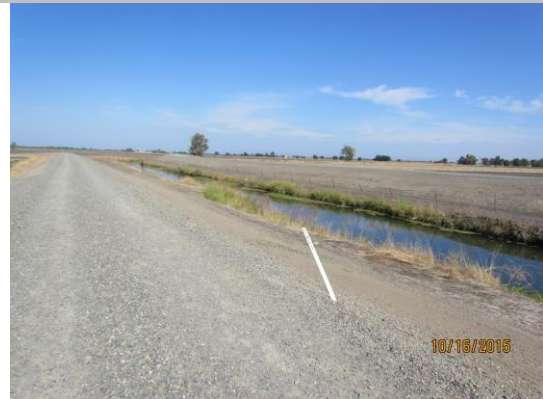
View of the erosion along the W/S toe.

View of the erosion along the waterside toe.
